# SERVICE BULLETIN CRACKS, WEAR AND DISTORTION ON THE CARBURETOR FLANGE

## ON ROTAX<sub>®</sub> ENGINES TYPE 912 AND 914 (SERIES)

SB-912-030 R1 SB-914-019 R1

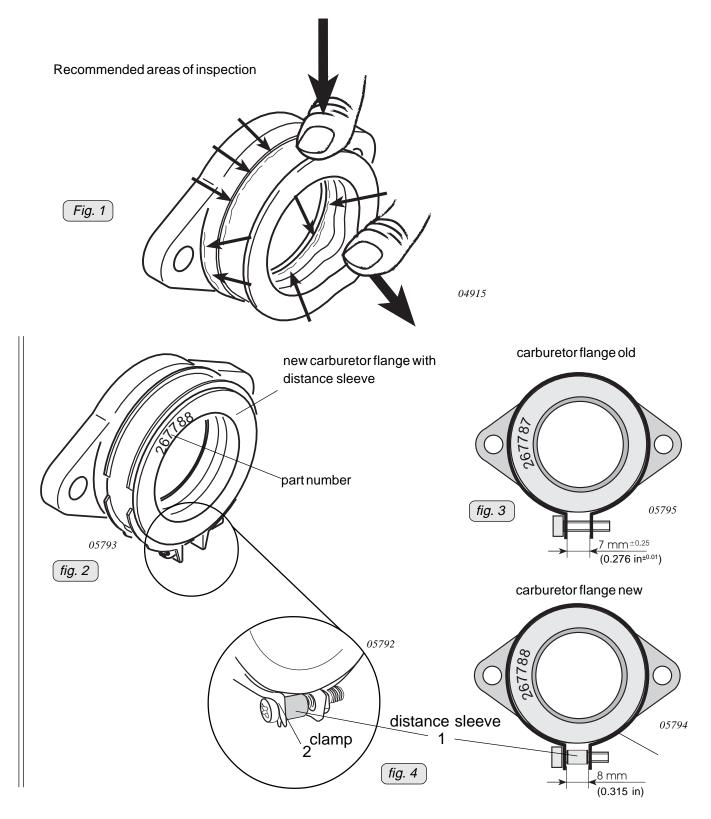
Cracks, wear and distortion on the carburetor flange on ROTAX, engine type 912 und 914 (Series)

Inspection of the carburetor flanges in accordance with the relevant Maintenance Manual and the information contained in Section 4) Appendix, Figure 1.

- Within the next 10 hours of operation the carburetor flanges must be inspected for damage, cracks, wear and distortion according to the following instructions in section 3. Replace with part no. 267788 as required.
- Every 50 hours of operation the carburetor flanges must be inspected for damage, cracks, wear and distortion according to the following instructions in section 3. Replace with part no. 267788 as required.
- ▲ WARNING: Non-compliance with these instructions could result in engine damage, personal injury or death!

Replacement/Installation of the carburetor flanges in accordance with the relevant Maintenance Manual. Tighten clamp (2) of the carburetor flange part no. 267788 with tightening torque 2.5 Nm (22 in.lb ) (see fig. 4).
